**TIPPERARY HISTORICAL JOURNAL
1994**

Excavations at Cormac's Chapel, Cashel, 1992 and 1993: a preliminary statement

By Brian Hodkinson

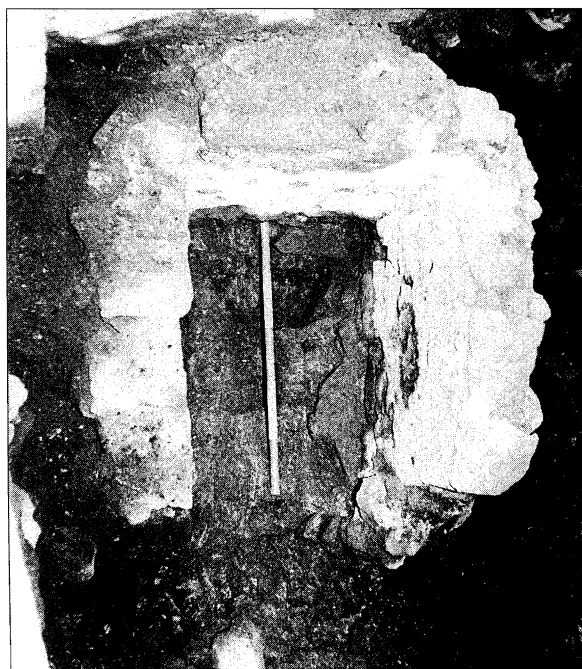
Fig. 3. The grave or shrine within the north porch, seen from the north door.

As the east side had been totally removed and the base of the feature was also missing, there were no finds within it to help determine its function. Its stratigraphic relationship to the chapel had been destroyed, but it is believed to have been inserted after the chapel was built. A close examination of the fabric at the base of the east side of the doorway shows that there have been some later alterations, with the use of limestone as opposed to the sandstone of the rest of the building, and the insertion of a narrow slab which may indicate the original lintel level of the feature. The feature is therefore interpreted as a large grave or shrine inserted into the north doorway.
